## Retrofitting of Existing RCC Buildings by Method of Jacketing

## **2. Retrofitting of health building at Nasik**

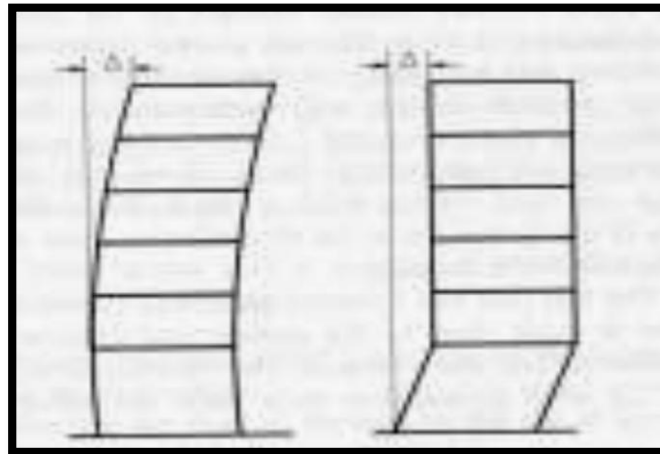
**Fig.1 Some damages those were occurred after earth quake at Gujarat in non engineered R.C.C building construction**

The inset shows large deformations were concentrated at column heads, which caused many soft storey failures, as per picture. Buildings if designed with uniform deflections of insert would have survived without collapse.”

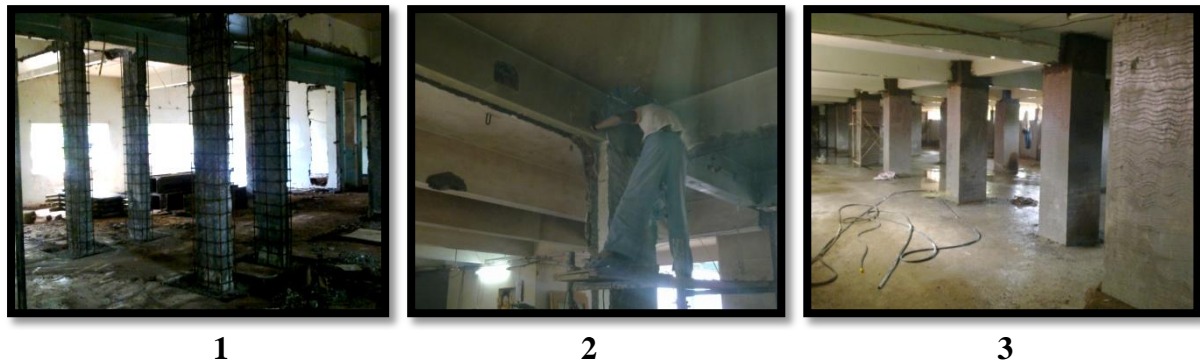
**(B)** All the columns should be jacketed. In the existing structure it was found that the columns were not centered properly in their position, due to which they were subjected to unwanted eccentric loads. Also the concrete in columns, beams, slabs was not compacted properly which created loose pockets & honey combs in the components. Suitable cover for the reinforcement was not maintained.

**View 1.** “Column jacketing at basement stage” **2.** “beam column junction strengthening in basement” **3.** “finished Column after jacketing work”

To overcome the above difficulties it was decided to jacket all the columns such that the eccentricity of loading will be reduced, the loose pockets of concrete will be capable to sustain the load to which the column is subjected & all the steel get the required concrete covering.

Figures shows the work of column jacketing for existing columns for additional strengthening, for its renovation work. These columns give the additional strength for its future use & make the structure safe against seismic forces.

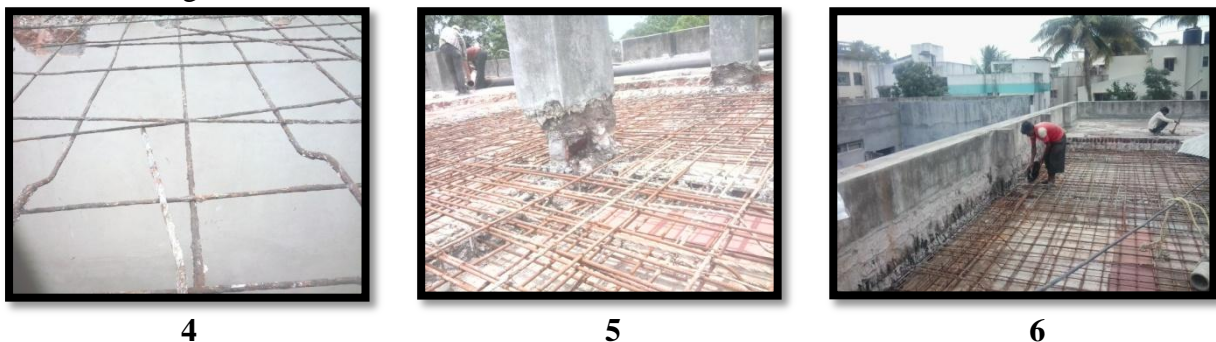
(D) The unwanted heavy loading of water proofing (IPS flooring) damaged the slab to greater extent.

**View 4.** “Rusting condition of existing slabs reinforcement” **6.** “Replaced slab reinforcement for existing rusted steel reinforcement.” **7.** “Application of chemical admixtures at the joint of new and old concrete”

Therefore, five slabs are entirely opened, strengthened with additional reinforcement and are casted with 150 mm thick M25 grade concrete layer.

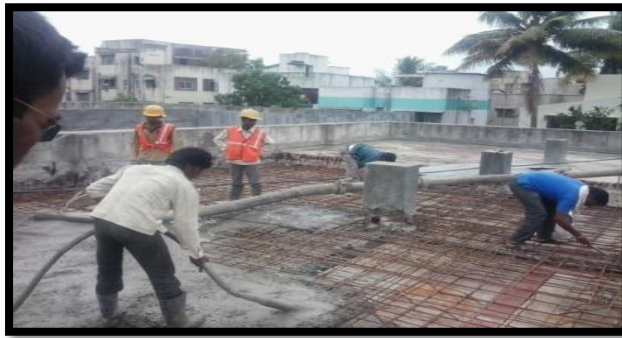
7

**View 7.** “compaction of concrete by needle vibrator and placement of cover blocks” **8.**“Finished slab - ready to cure”
